# STRUCTURAL ASSESSMENT

UCSB BUILDING #406

January 6, 2017

Re: Building #406 Structural Damage Assessment

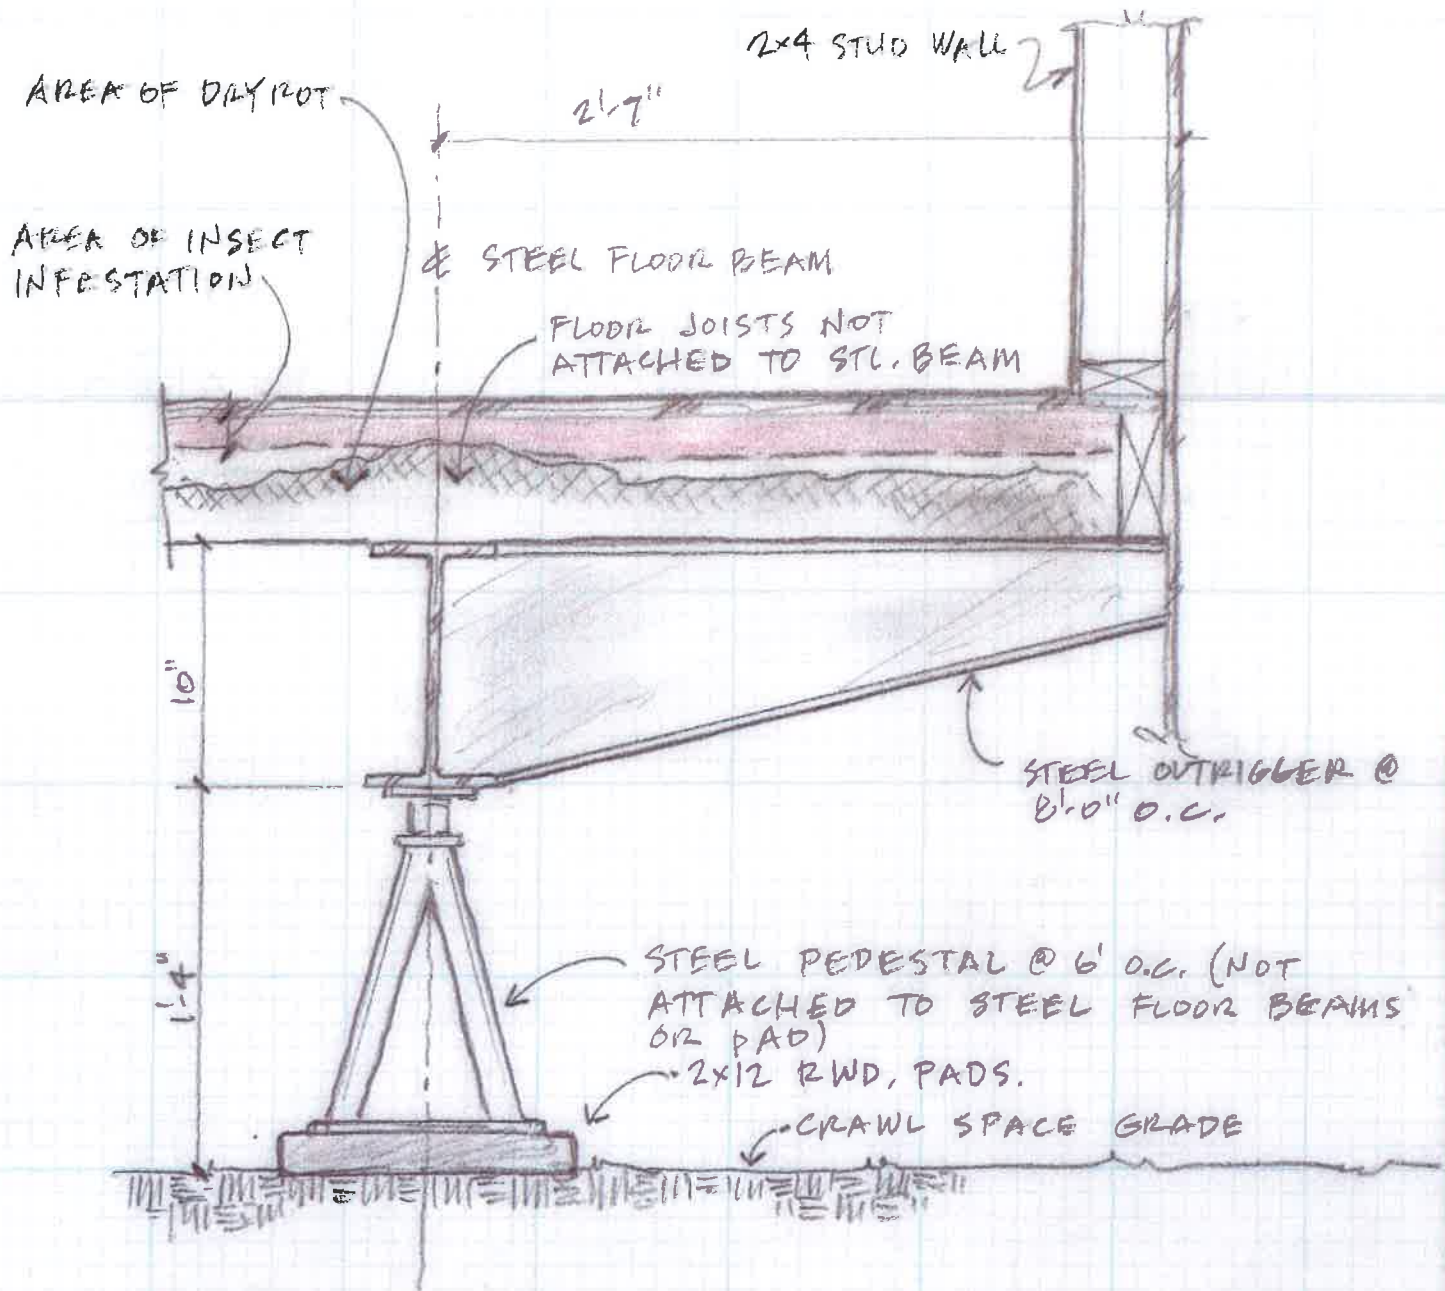
TYPICAL FLOOR SECTION AT PERIMETER

Currently, no structural foundation system exists to prevent the building's collapse in the event of a significant seismic event (Reference detail sketch SK-2). The building would simply shift laterally, either tipping over all the rusted metal tripod supports, or simply sliding of the top of these supports due to the lack of a proper connection. Such a motion and impact of the frail wood building on the ground below could be enough to distort and collapse the walls and roof above with potentially tragic consequences.

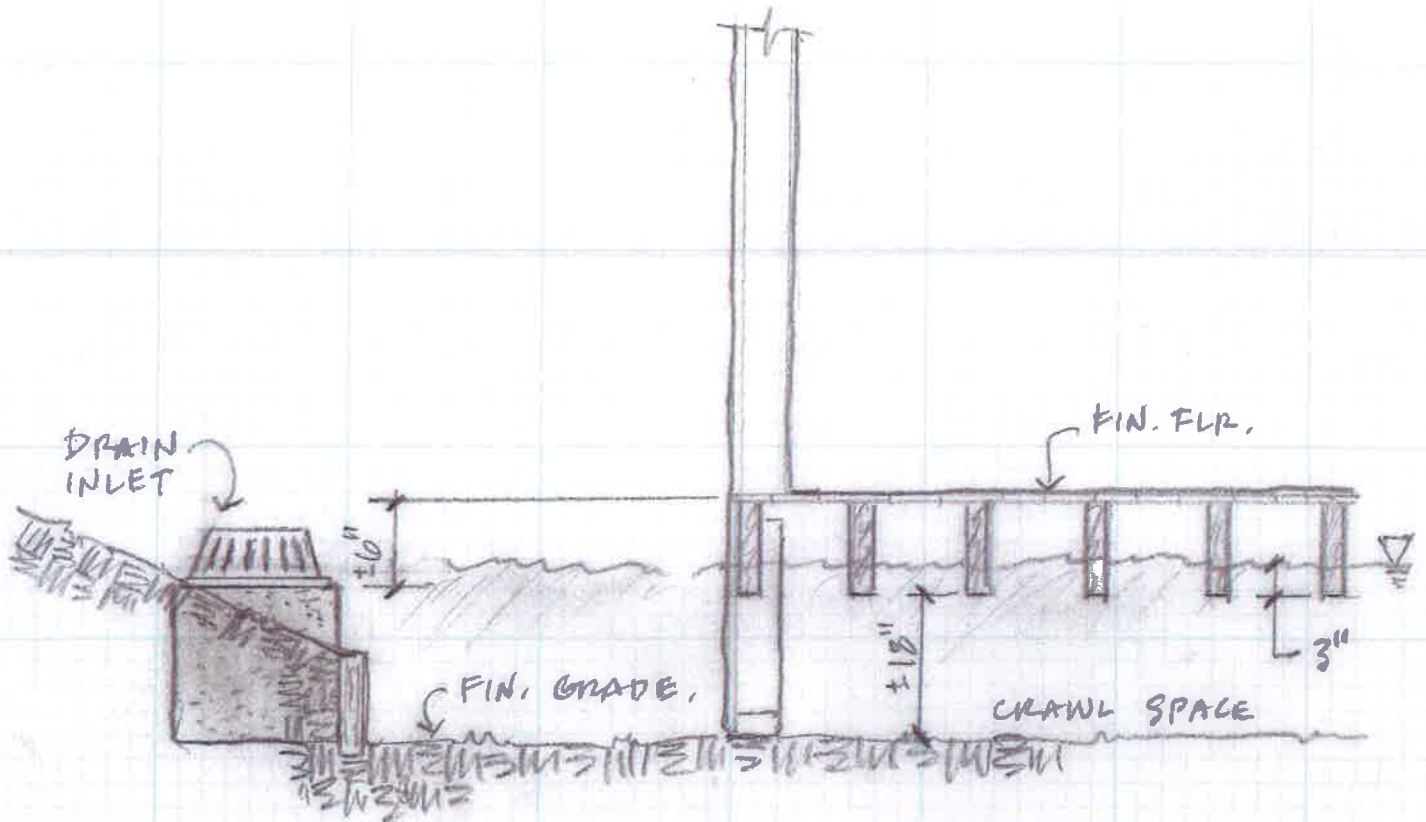
CROSS-SECTION SHOWING RELATIONSHIP  
OF DRAIN INLET TO CRAWL SPACE & FIN. FLR.

Not only are the metal tripods that support the building resting on a wood block on top of the soil, but the under-floor soil grade is not higher than the exterior soil grade which allows water intrusion into the crawl space (Reference detail sketch SK-3). The resulting saturated condition (mud) greatly reduces the capacity of the soil to support the weight of the building in addition to creating a moist environment which promotes mold, dryrot and insect infestation. The crawl space is not drained or adequately ventilated causing serious structural damage and increased risk of collapse, in addition to health risks to inhabitants where mold growth is encouraged.

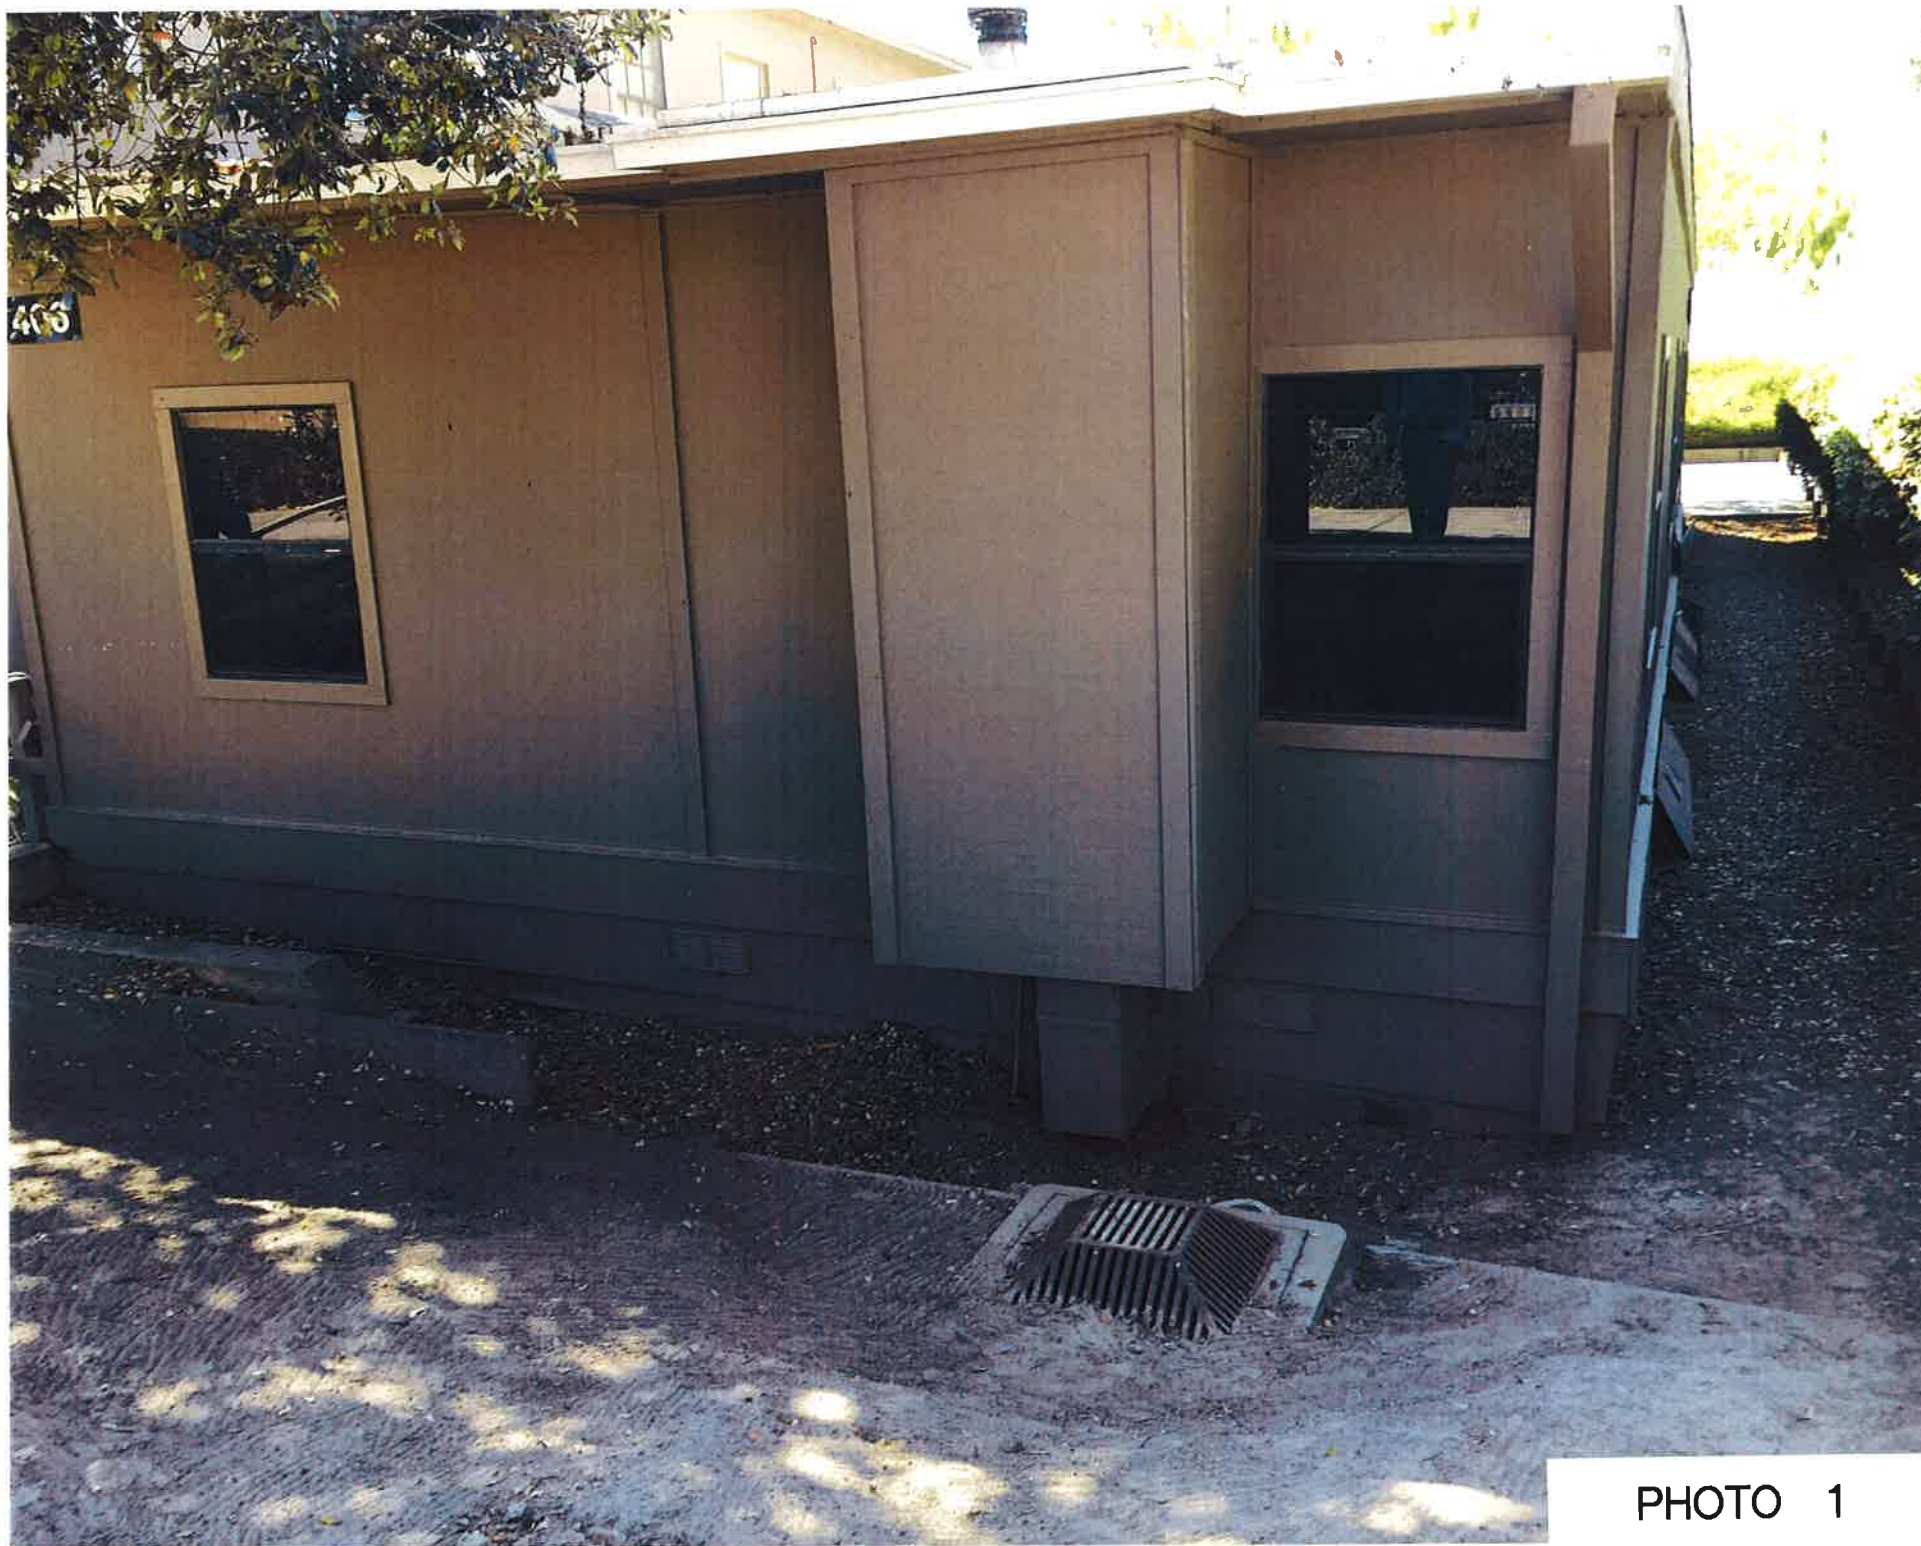
PHOTO 1

On September 15, 2016, I met with you and facilities staff to assess what appeared to be fairly extensive insect and dryrot damage to a 30 to 40 year old single story wood frame premanufactured building as shown in photo #1.

Photo #1 shows that the under-floor ventilation is inadequate, and the area drain is set several inches higher than the lowest grade adjacent to the building.

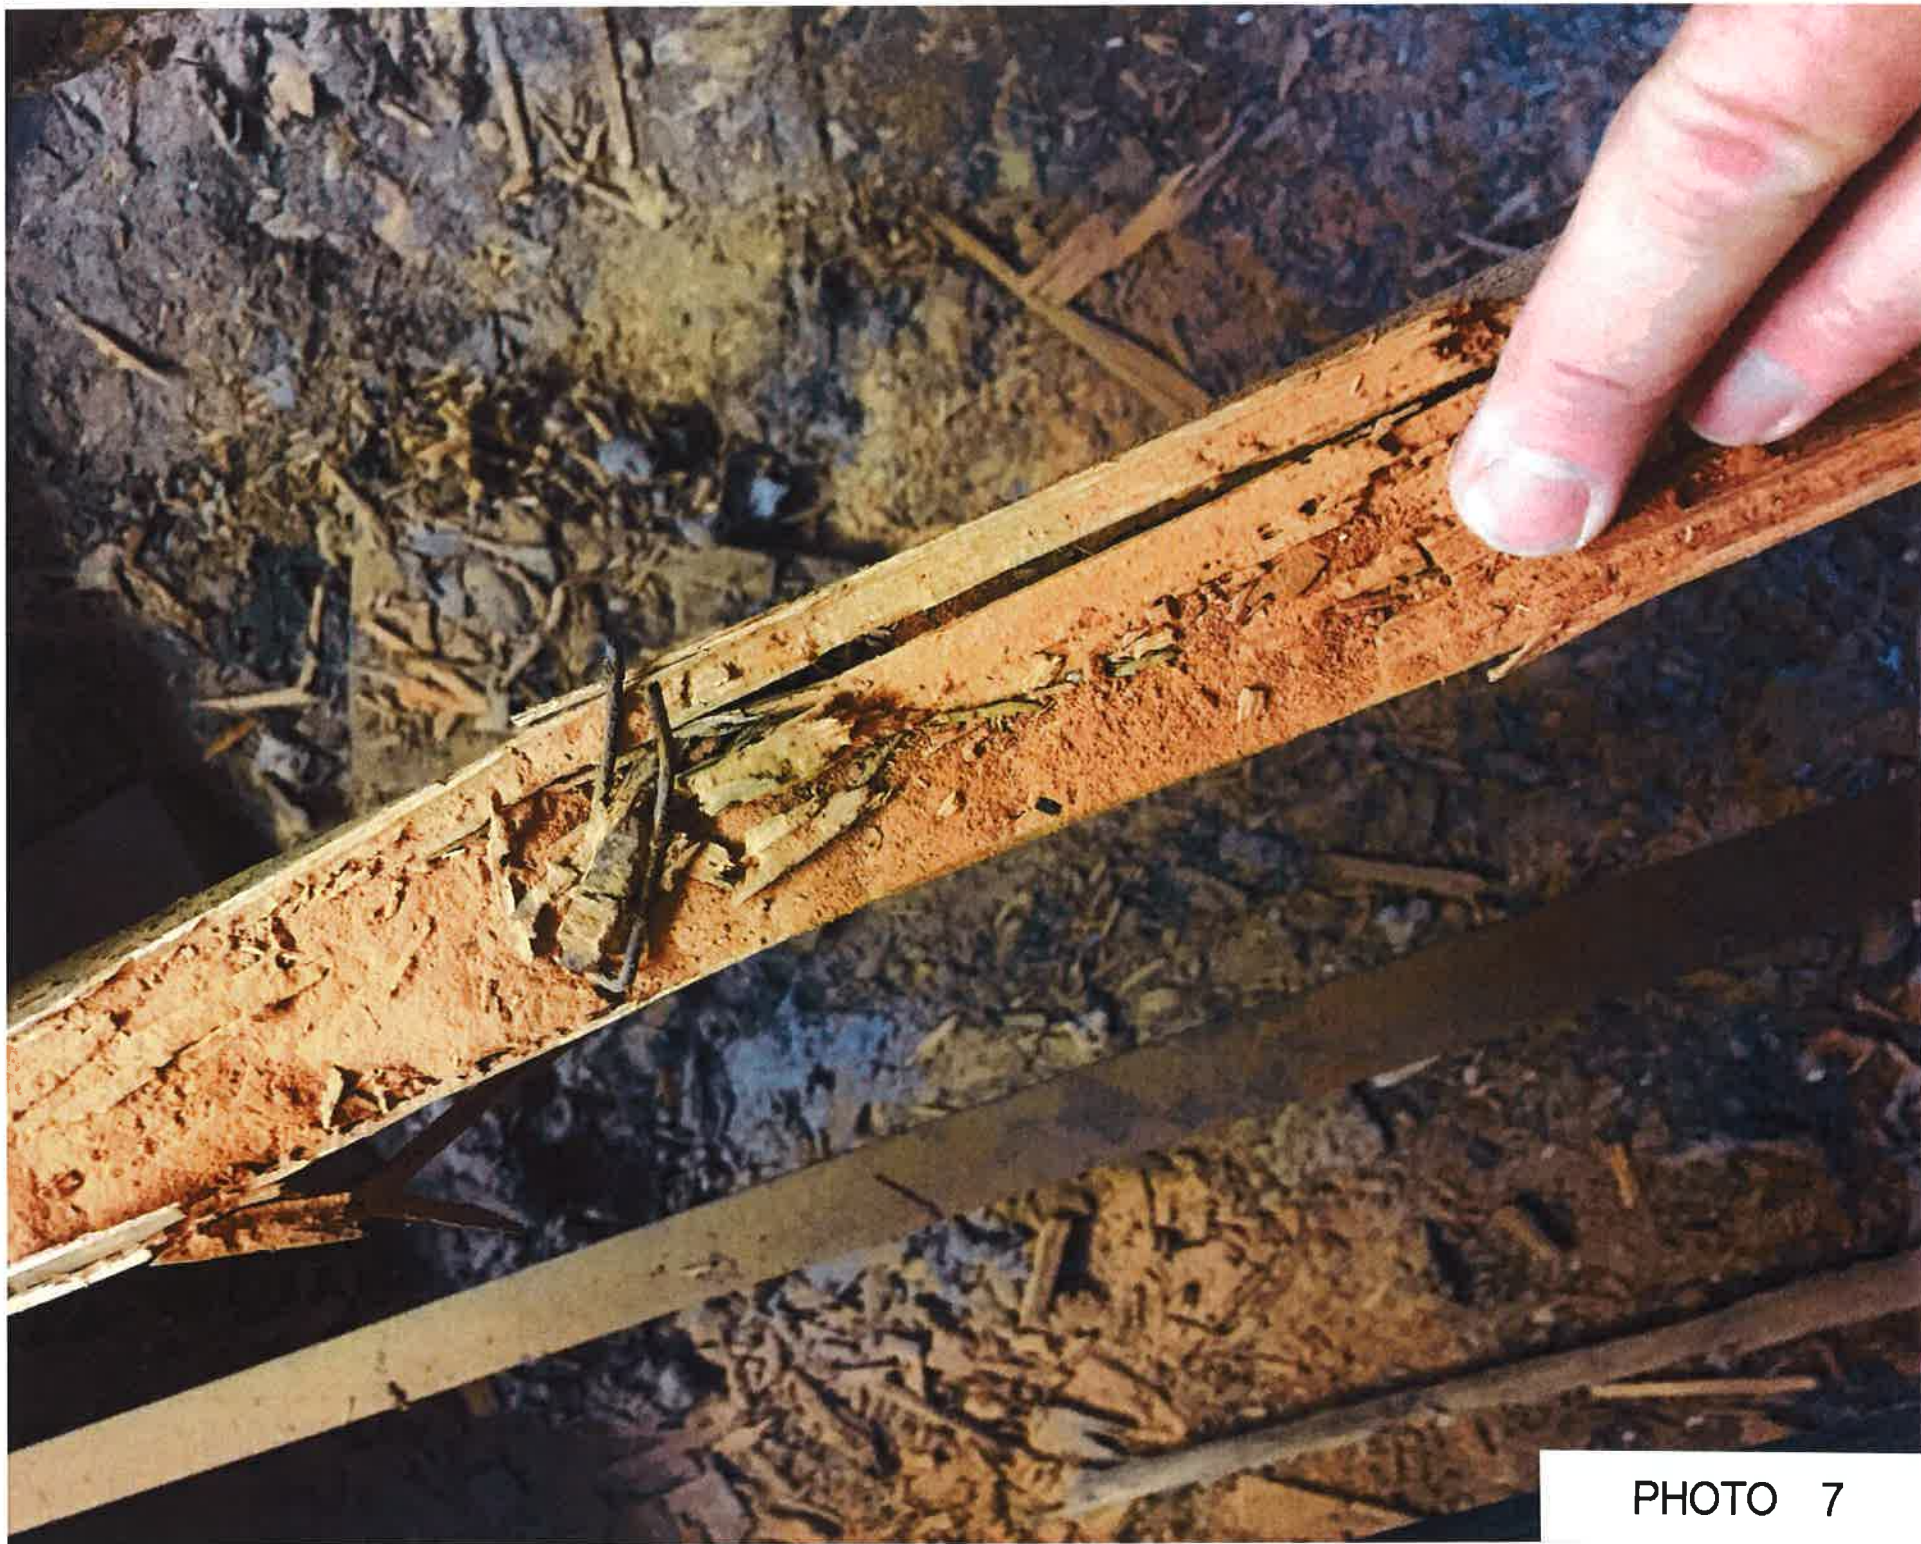
PHOTO 7

Photos #7 thru #11 exhibit damage to wood floor joists and plywood sheathing caused by insect infestation and dryrot.

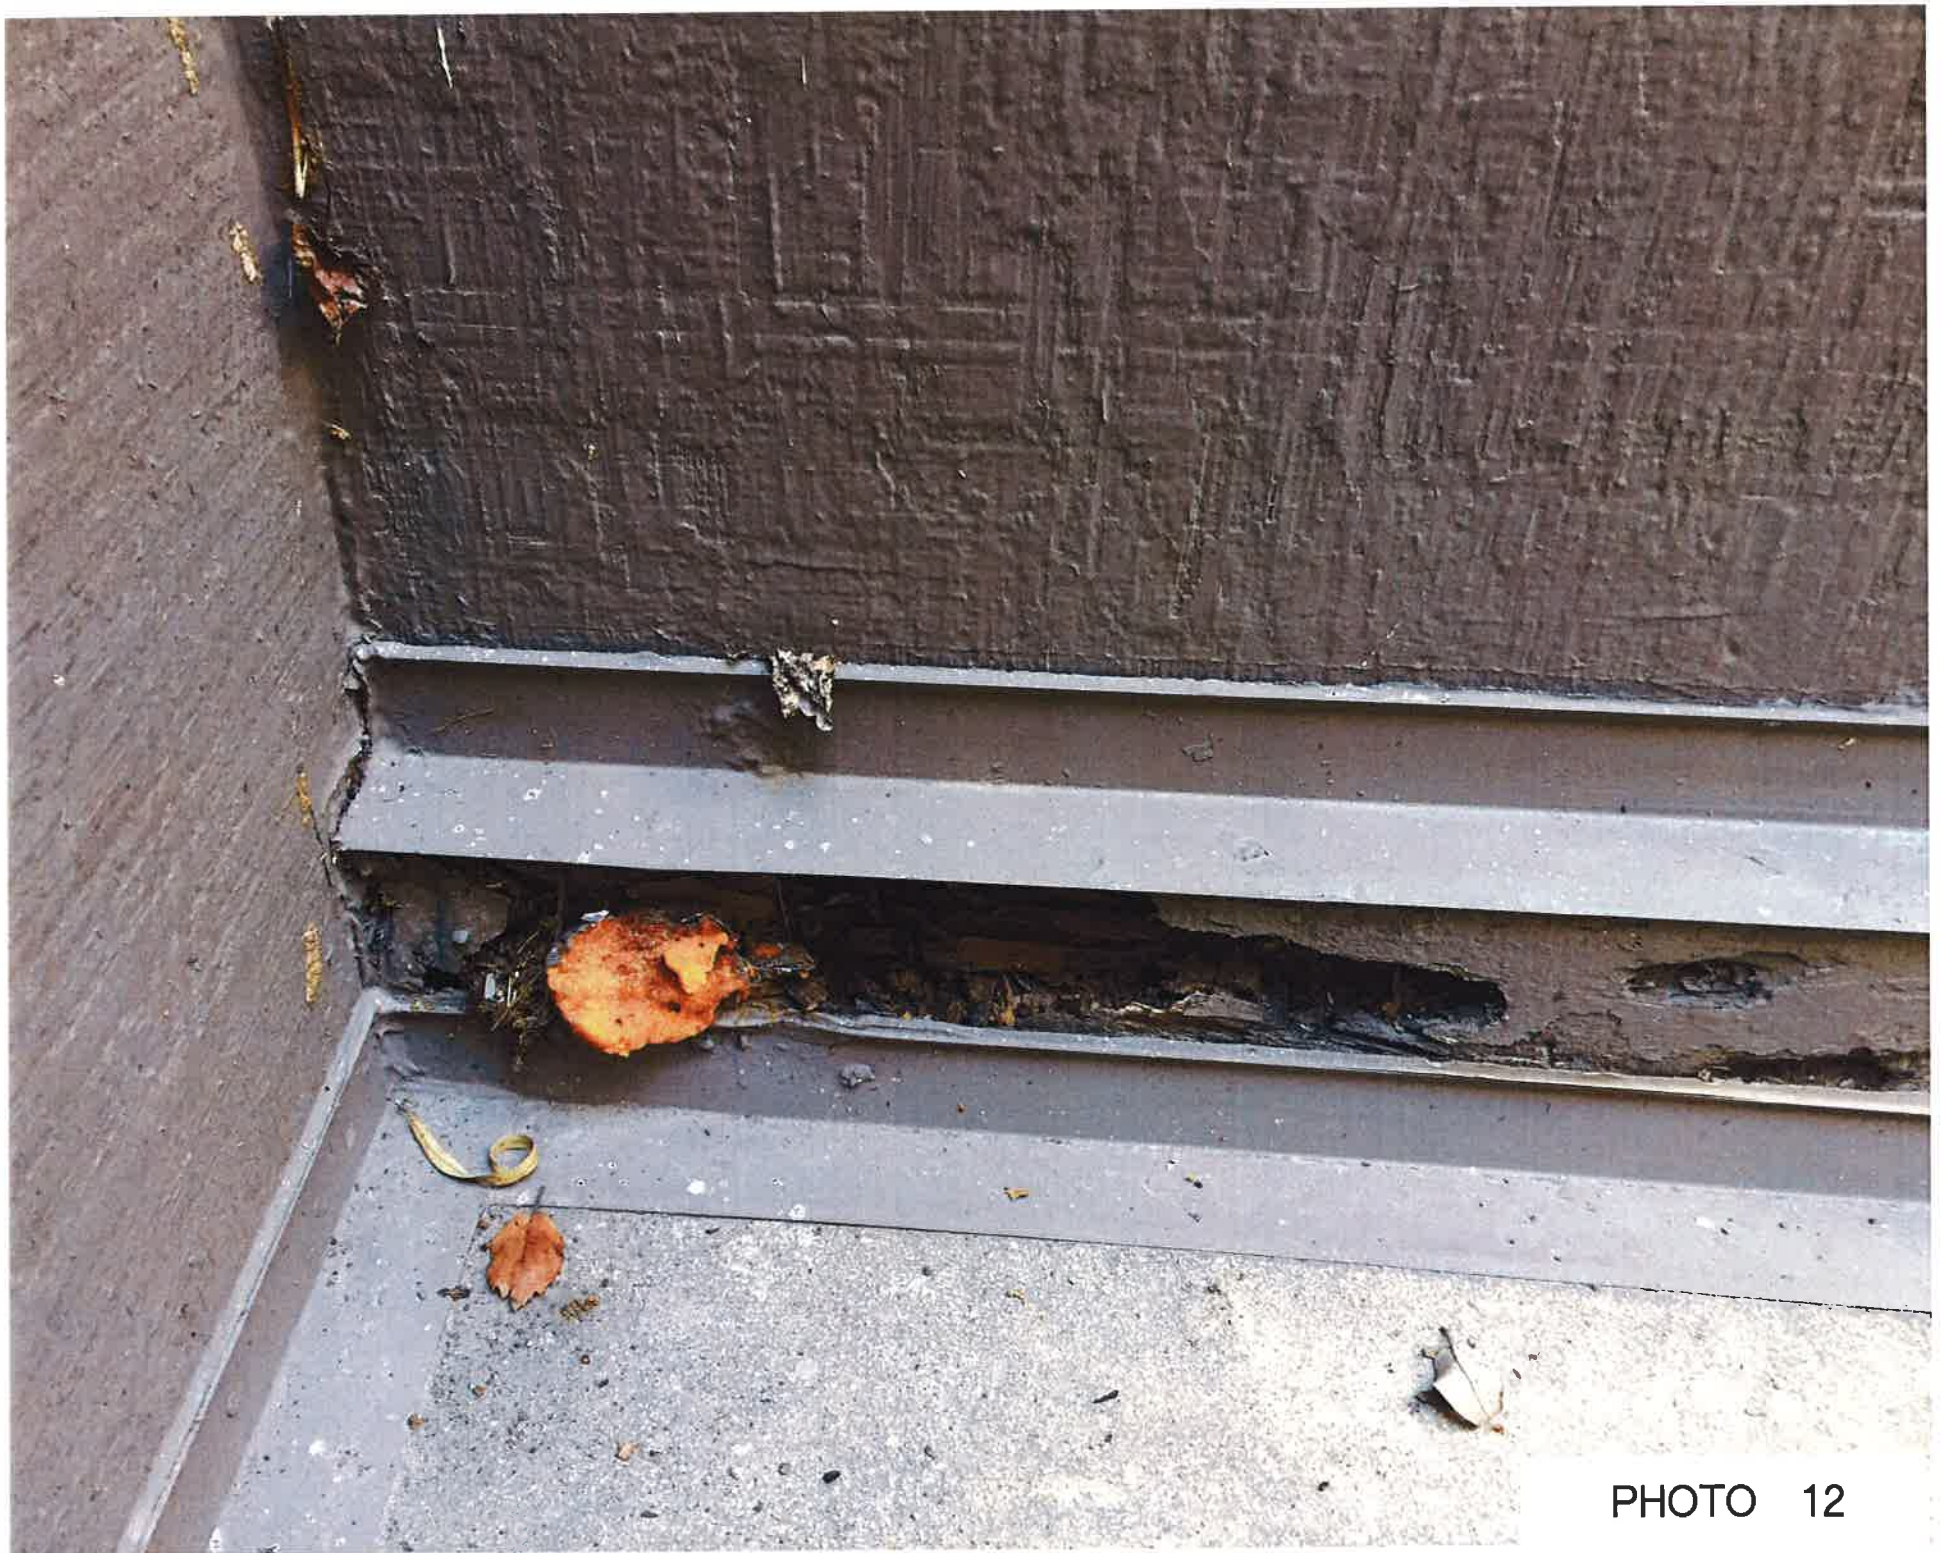
PHOTO 12

Photos #12 thru #15 show extensive insect and dryrot damage to wood framing and exterior plywood siding where in contact with soil and areas where moisture is in contact with these unprotected materials.

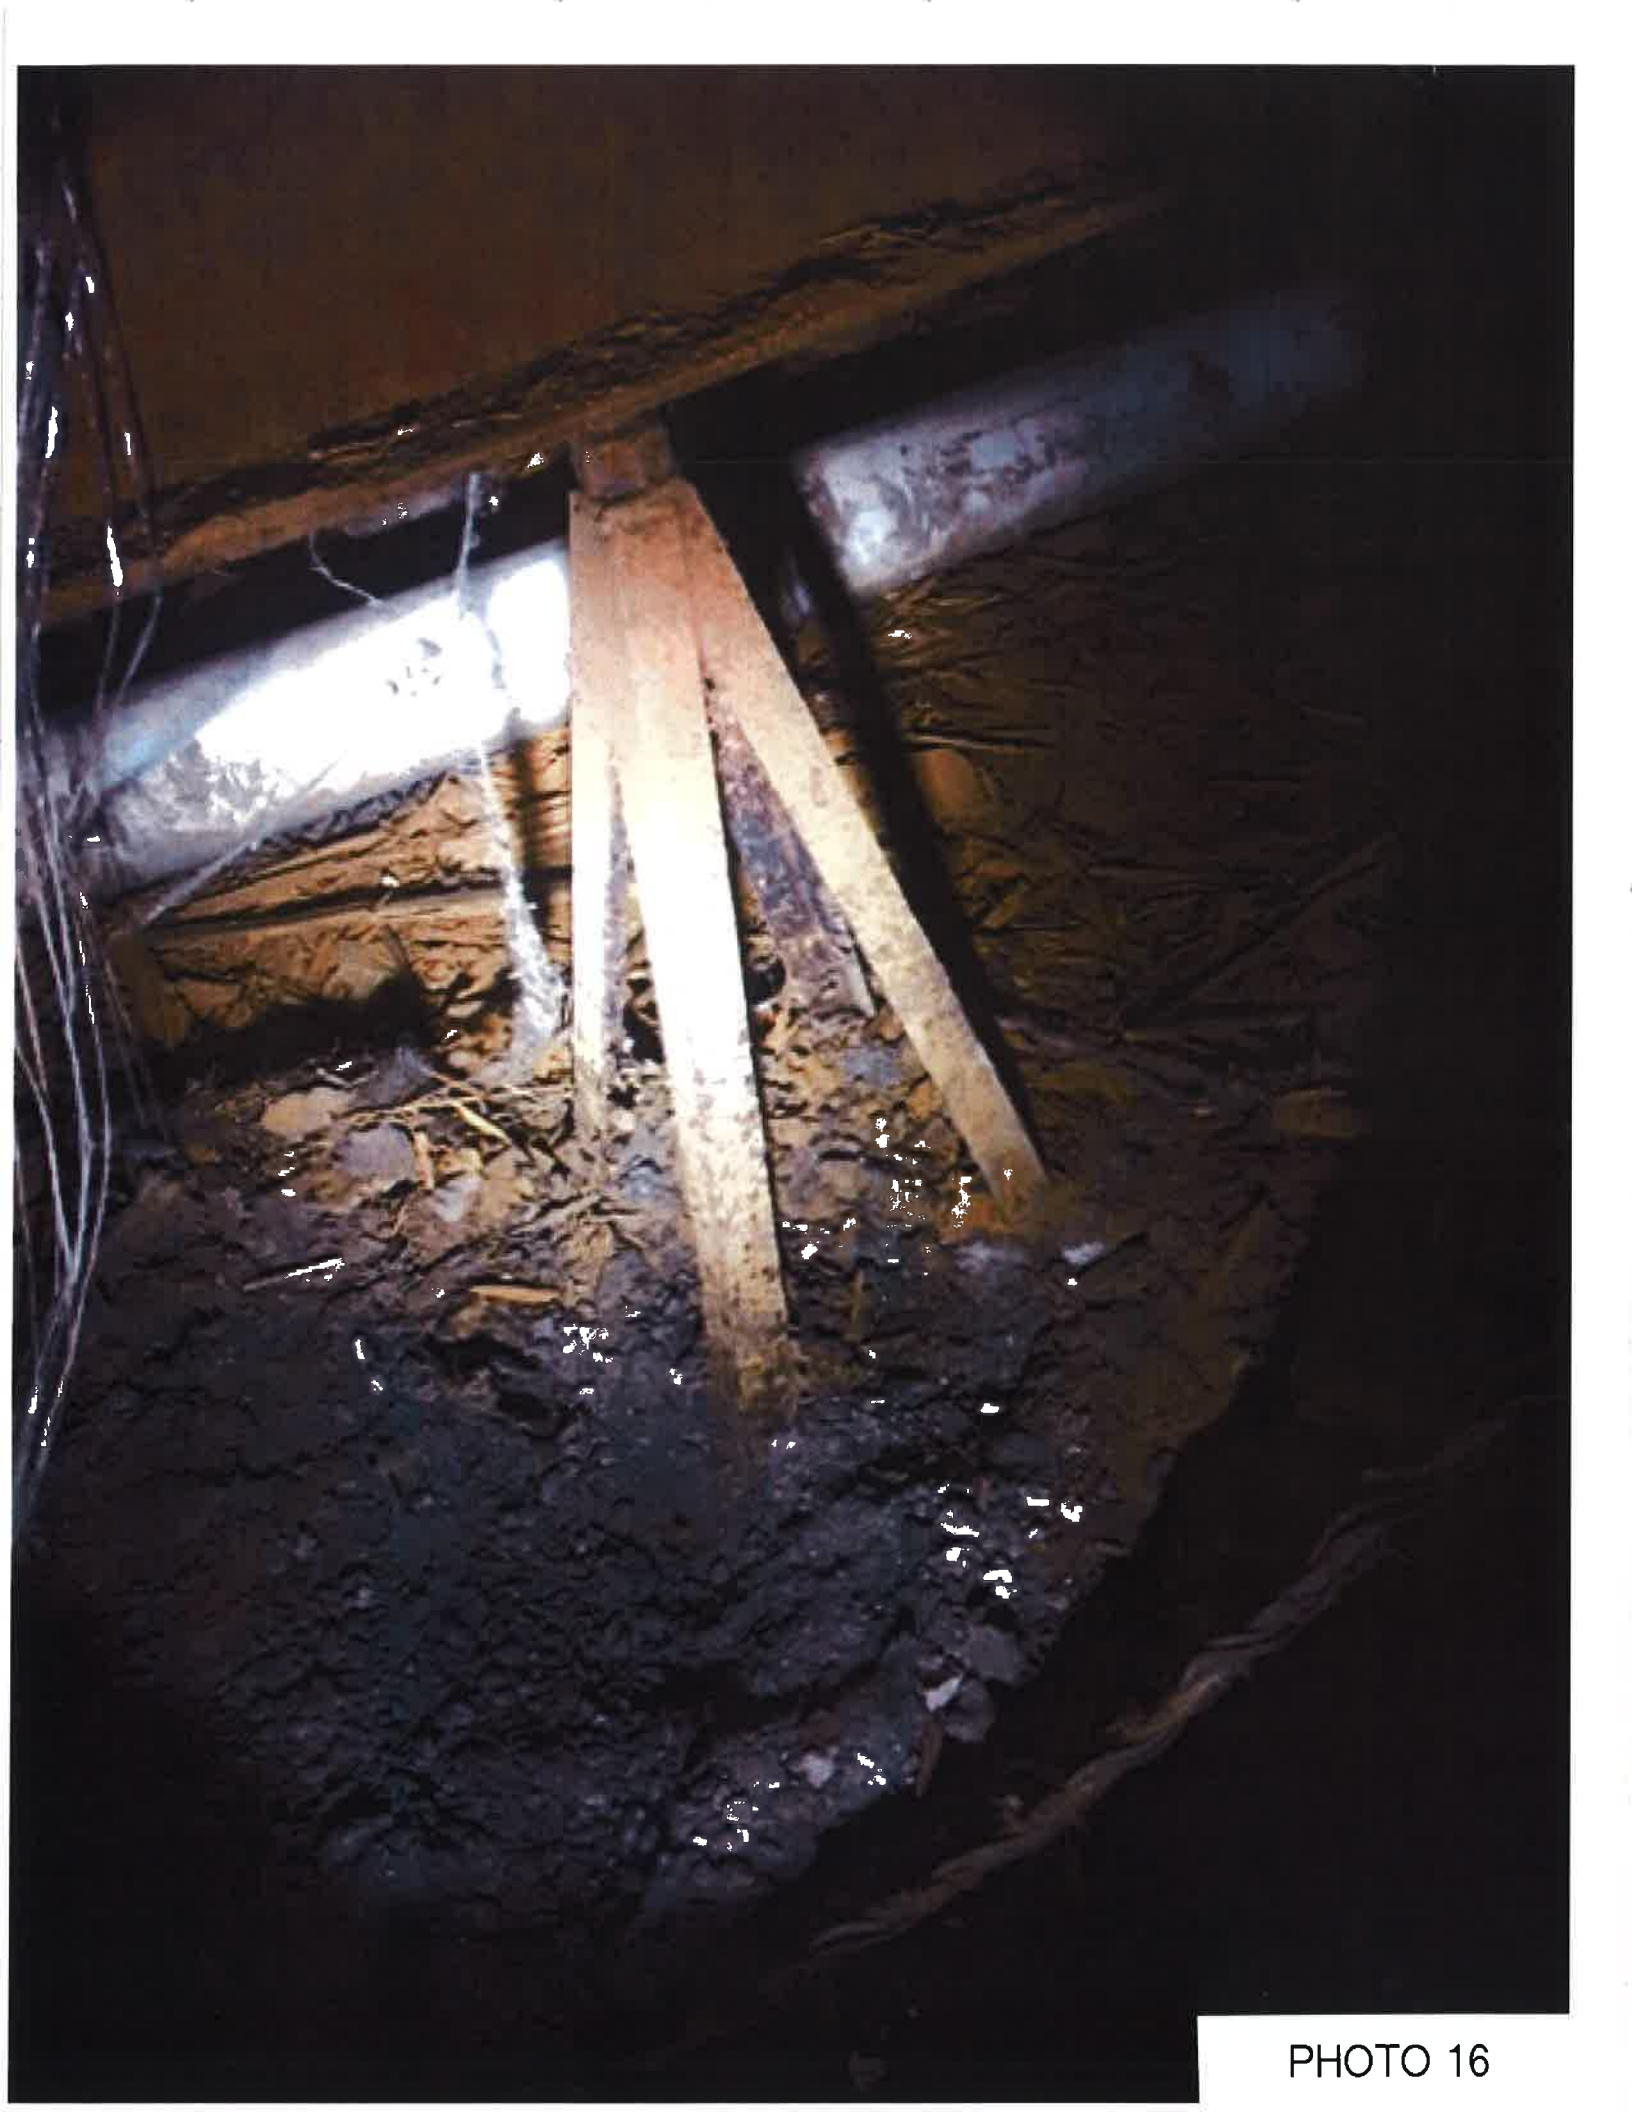
PHOTO 16

The rusted metal tripods (photos #16 thru #19) supporting the main steel floor beams are not connected to the beams and are also not connected to a reliable pad foundation.

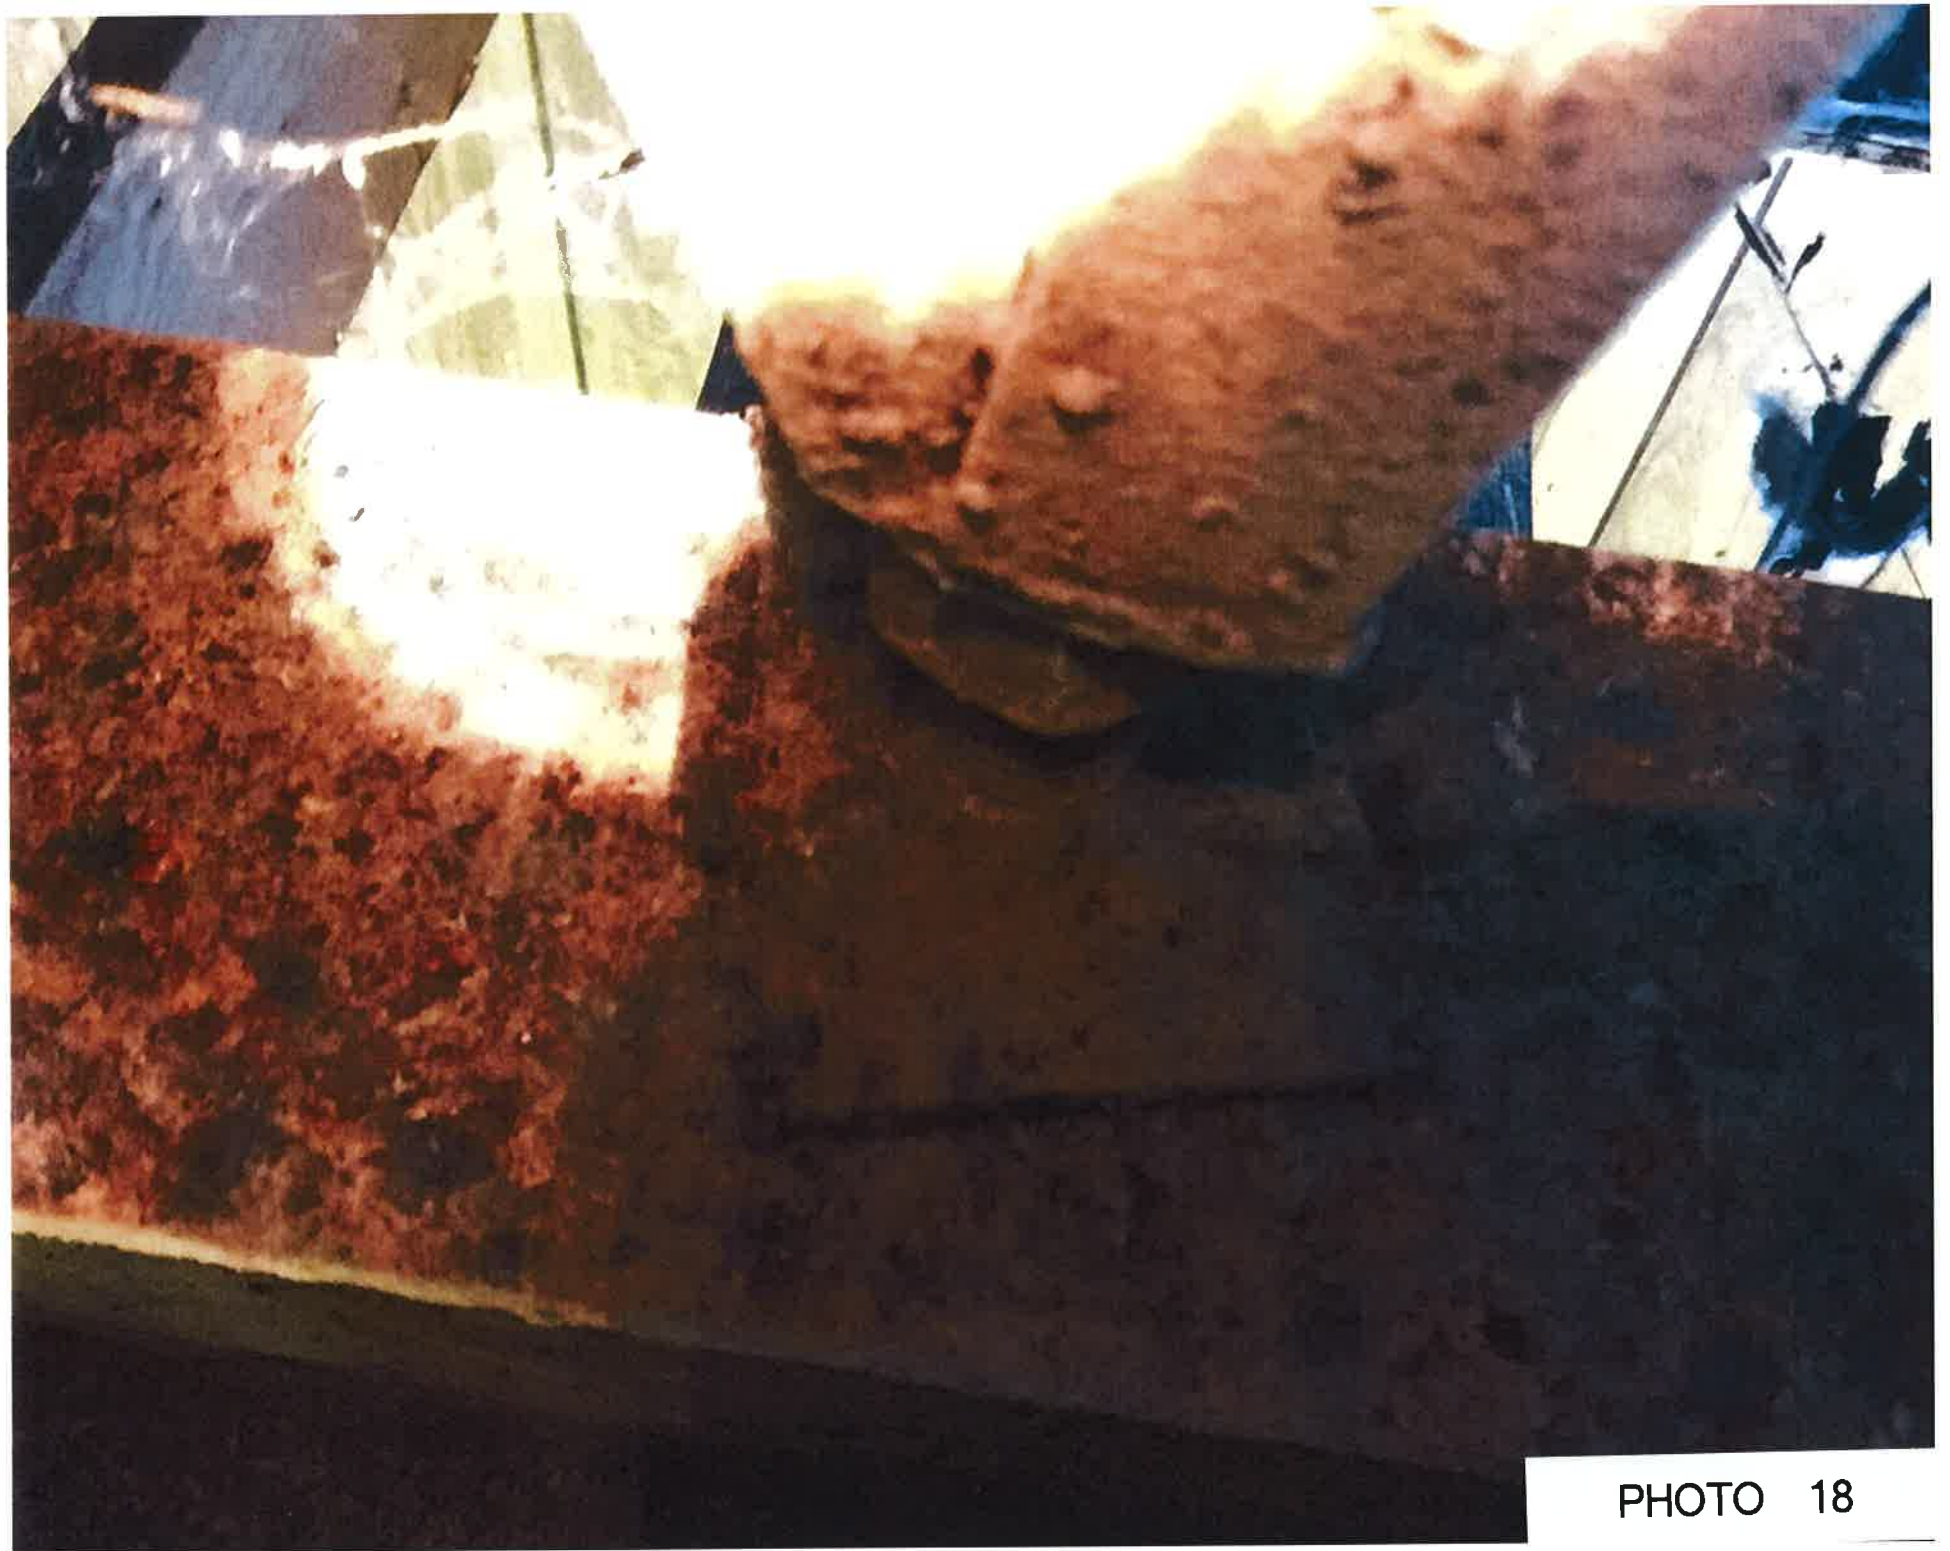
PHOTO 18

The main steel floor beams and the supporting tripods have significant rust scale, reducing their load-carrying capacity. In addition, as mentioned earlier, there appears to be no connection between these important structural elements. Photo #18 shows no connection between the tripod and the steel beam while photo #20 indicates no attachment of the floor joists to the main steel floor beams.

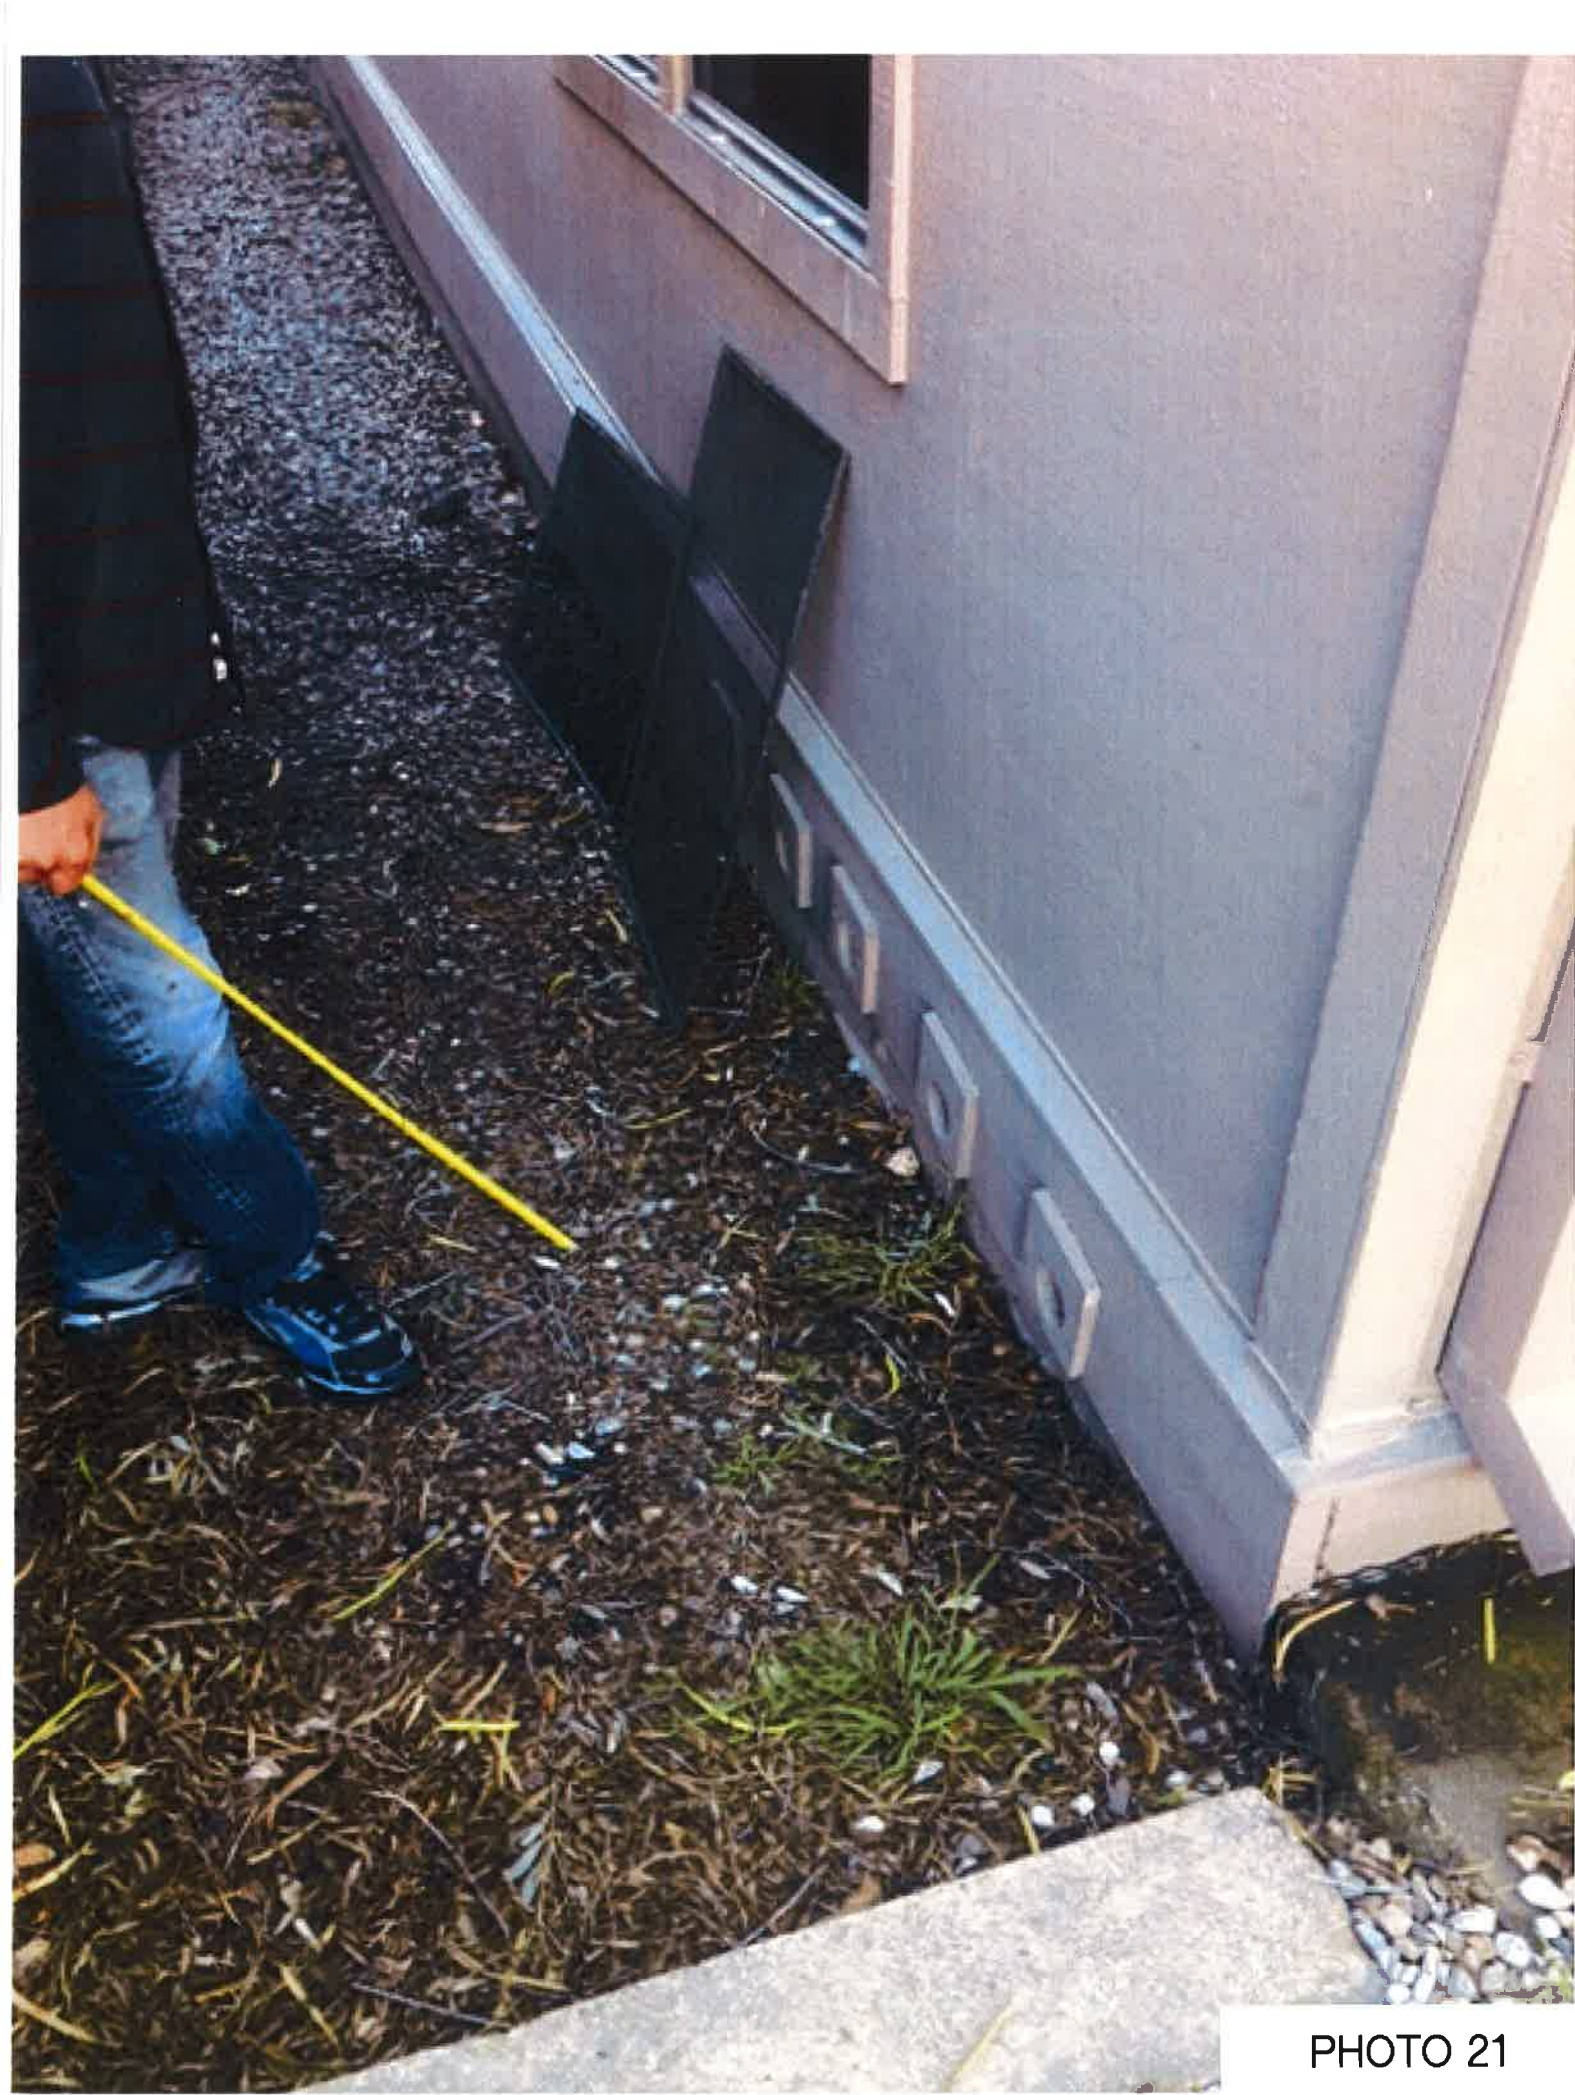
PHOTO 21

It appears that adequate ventilation was not provided for the existing crawl space which promoted the dryrot and insect problem. The only ventilation provided is what is shown in photo #21.
